**TECHNICAL FINDINGS
FROM
FULL SCALE VEHICLE BARRIER IMPACT TESTS**

By
Eric F. Nordlin
and
Robert N. Field

Presented at the Seventh Annual
Stapp Car Crash Conference
Playa Del Rey, California

November 11, 1963

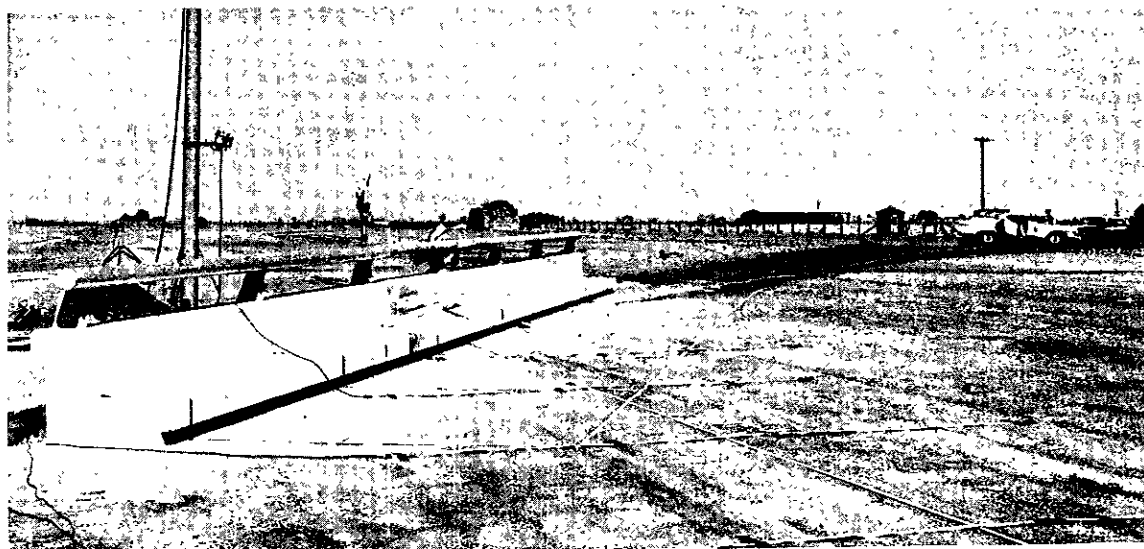
Test B-1 Type 2 Bridge Barrier Rail

Standard Type 2 with aluminum posts and pipe railing. Height of concrete parapet: 28". Height of walkway: 10". Over-all height of barrier: 43"

1. The vehicle did not penetrate the barrier rail. There was no evidence of rising even after crossing the walkway (Exhibit 5). However, it should be noted that previous tests (Reference 2) showed that there was a tendency to jump when the 10" high curb is struck at lower speeds and flatter angles.

2. All parts of the system remained intact. Damage to the concrete was minimal consisting of slight spalling and cracking.
3. There was a smooth progression of the vehicle through impact, even though the fender was torn from the body and lodged between the rail and parapet at the impact post.
4. Evidence of a slight spalling and scraping of the concrete was confined to the immediate impact area. Cracking occurred at the junction of the backwall and the walkway. The web of the first post contacted was ripped its entire length adjacent to the base. One section of the aluminum pipe railing was slightly gouged by the vehicle fender and was bent approximately 2 inches (see Exhibit 6).

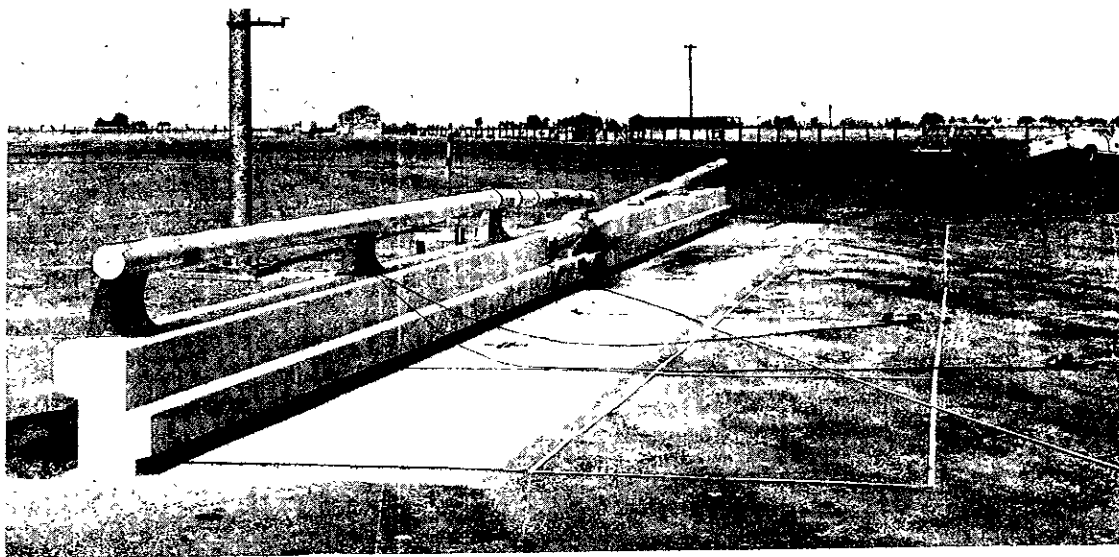
Test B-2 Type 1 Bridge Barrier Rail

Standard Type 1 with aluminum posts and pipe railing. Height of concrete: 21". Over-all height of barrier: 36".

1. Although the vehicle did not penetrate the barrier, it rose approximately 12 inches within 6 feet after initial contact due to excessive deflection of the railing (20 inches). This rise placed critical loading on the railing elements which resulted in their subsequent failure (Exhibit 7).
2. Three posts and three sections of the aluminum pipe railing were torn from the parapet and dropped to the ground behind the barrier. Major cracks developed in the concrete parapet.

3. The vehicle progressed fairly smoothly through impact even though the frame dragged on top of the parapet and sheared three posts before leaving the barrier. Excessive deflection of the railing elements and resultant vehicle jump imparted a rolling moment to the vehicle that almost caused a post-impact roll over.
4. Deep spalling and severe cracking of the concrete occurred in the impact area. Three posts were completely sheared from the barrier, and the web of the last post struck was bent. Three sections of the aluminum pipe rail were knocked to the ground behind the barrier; however, the sections remained intact and connected to the last post. Had there been adequate clearance behind the barrier for the pipe to drop, it is felt that the three pipe sections would have broken from the system and fallen to the ground (see Exhibit 8).

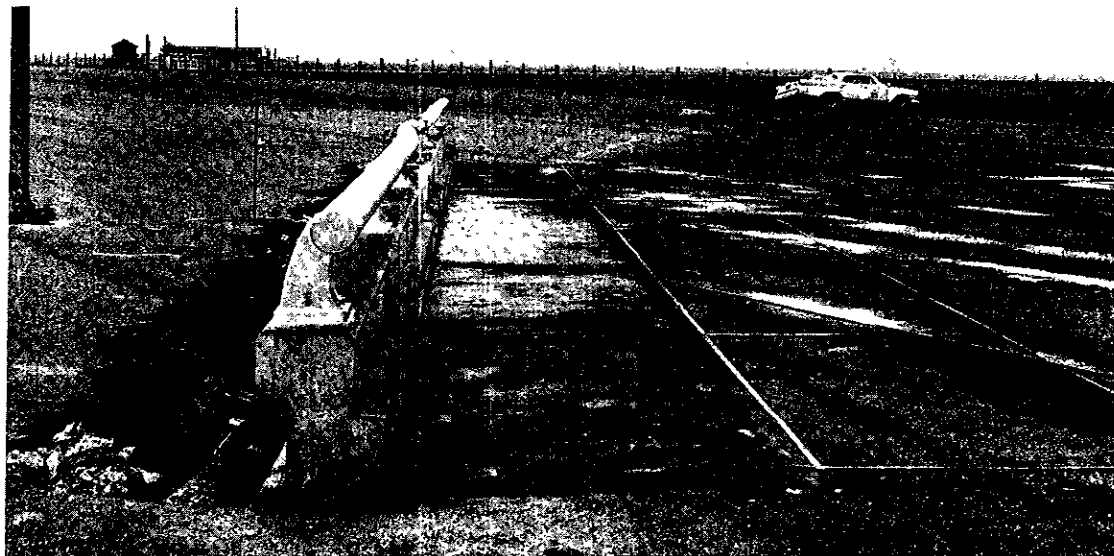
Test B-3 Type 1-A Bridge Barrier Rail

Type 1 parapet with welded steel plate posts and steel pipe railing. Height of concrete: 21" (repaired after Test B-2). Overall height of barrier: 36".

To test the currently designed parapet with the steel posts and steel pipe rail. The posts and rail were purposely over-designed so that they would not fail under impact loading. It was felt that this test would indicate the maximum performance of the concrete parapet and would assist in determining the relative loading on each part of the system.

3. The vehicle progressed smoothly through impact with no tendency to roll.
4. The concrete developed deep cracks behind the first steel post contacted and required replacement of a small section of concrete around the anchor bolts. The front face of the concrete parapet was severely scraped and spalled in the impact area. One section of the steel railing was bent approximately 4 inches and deeply gouged. The welded steel plate posts sustained the impact with no evidence of damage (see Exhibit 10).

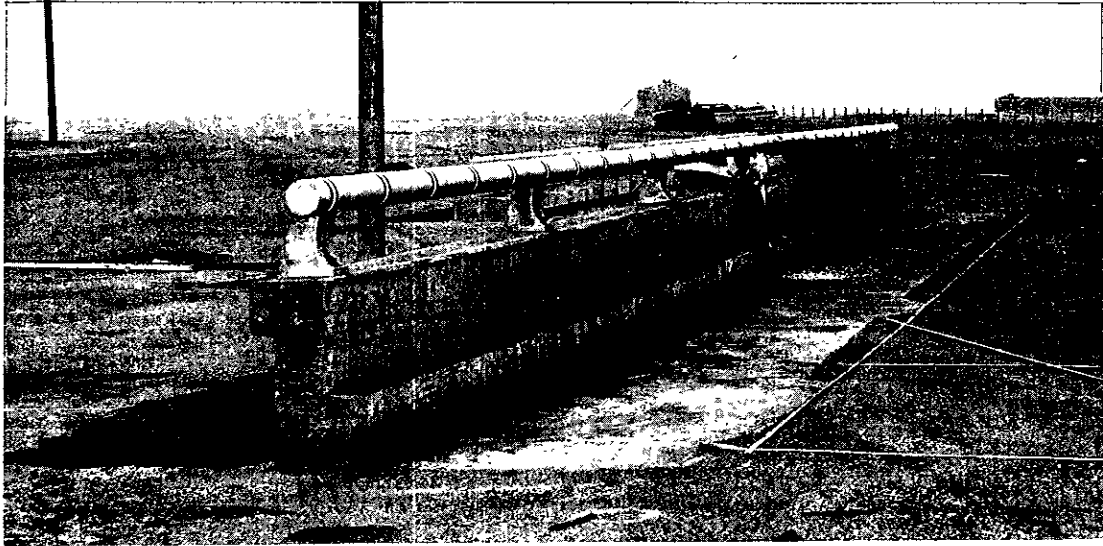
Test B-4 Type 1 Modified Bridge Barrier Rail

Modified Type 1 concrete parapet with aluminum posts and aluminum pipe railing. Height of concrete: 28". Over-all height of barrier: 43".

1. The vehicle did not penetrate the barrier. There was very little tendency for the vehicle to rise and no tendency to climb (Exhibit 11).
2. There was no structural failure in any of the barrier elements.

3. The vehicle progressed reasonably smoothly through impact considering that the front left fender and door panel were torn from the vehicle and lodged between the pipe rail and parapet at the first post after impact .
4. Slight spalling and scraping of the concrete was confined to the immediate impact area. The flange of the first post contacted was bent and would have required replacement; however, there was no evidence of failure. One section of the aluminum pipe rail was bent 2 inches (Exhibit 12).

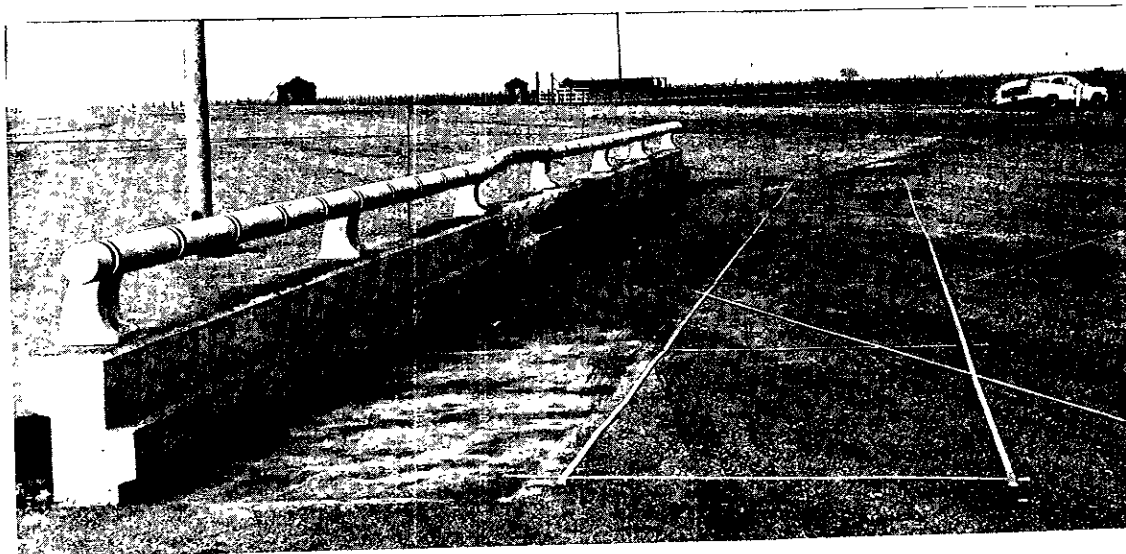
Test B-5 Type 1-B Bridge Barrier Rail

Type 1 parapet with malleable iron posts and aluminum pipe railing. Height of concrete: 21" (repaired after Test B-3). Overall height of barrier: 36".

To determine the efficiency of the currently designed parapet with malleable iron posts under impact loading conditions similar to that of Test B-2.

3. The vehicle progressed smoothly through impact with no tendency to roll .
4. A moderate amount of spalling of the concrete behind the anchor bolts on the first post after impact would have required an epoxy/sand patch and resetting of the anchor bolts to place the barrier in operating condition (see Exhibit 14). The epoxy/sand anchor bolt repair from Test B-3 withstood direct impact with no evidence of failure.

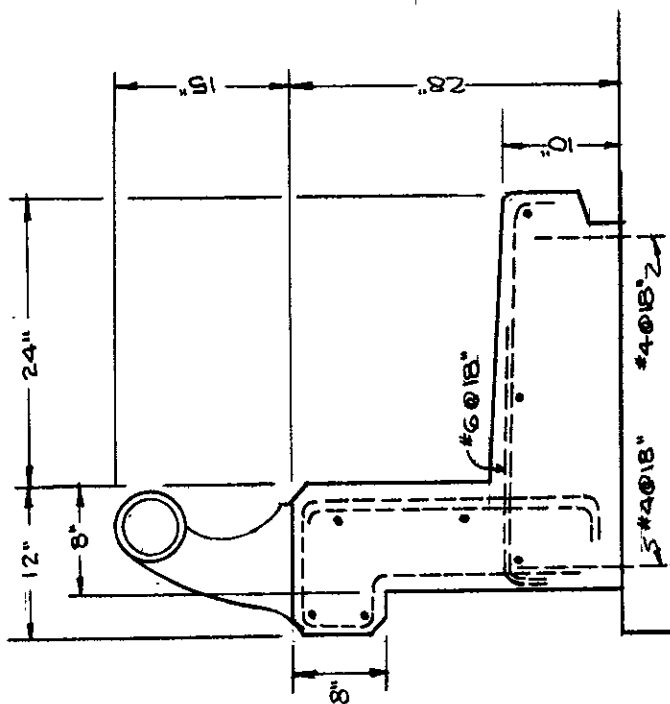
B. CALIFORNIA STANDARD
BRIDGE BARRIER RAILING
TYPE 2

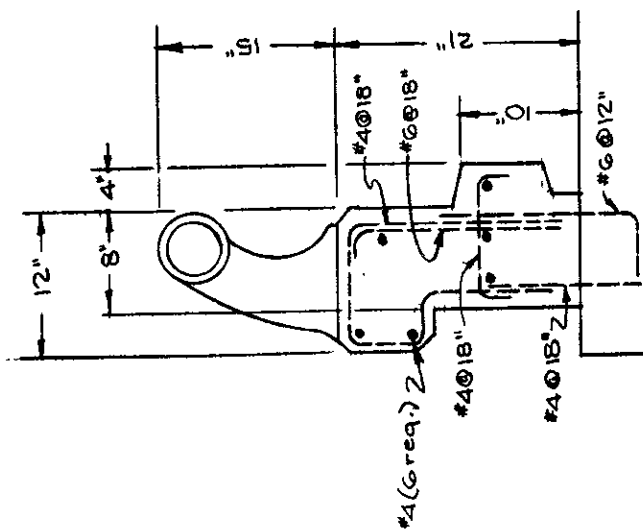
A. CALIFORNIA STANDARD
BRIDGE BARRIER RAILING
TYPE 1

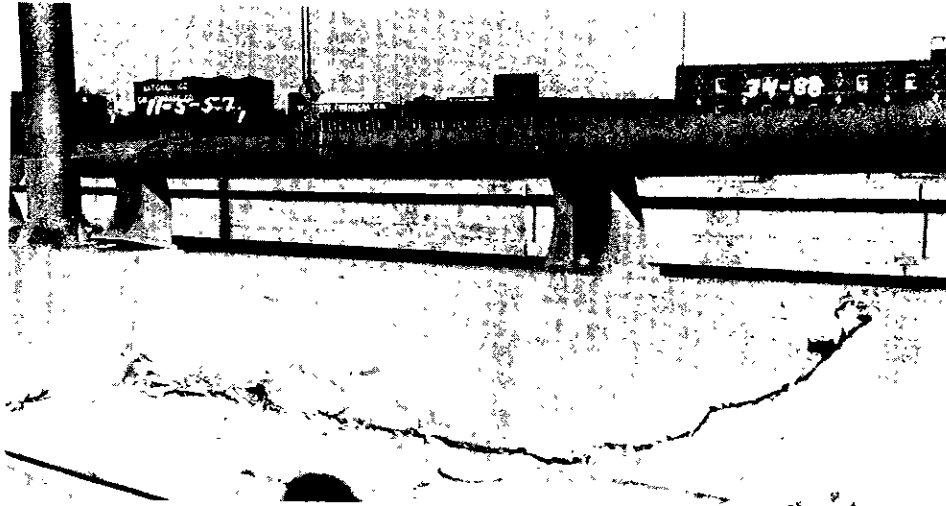
A. Early Barrier Prototype showing insufficiency of reinforcing steel in parapet. (Also see Exhibit 2A).

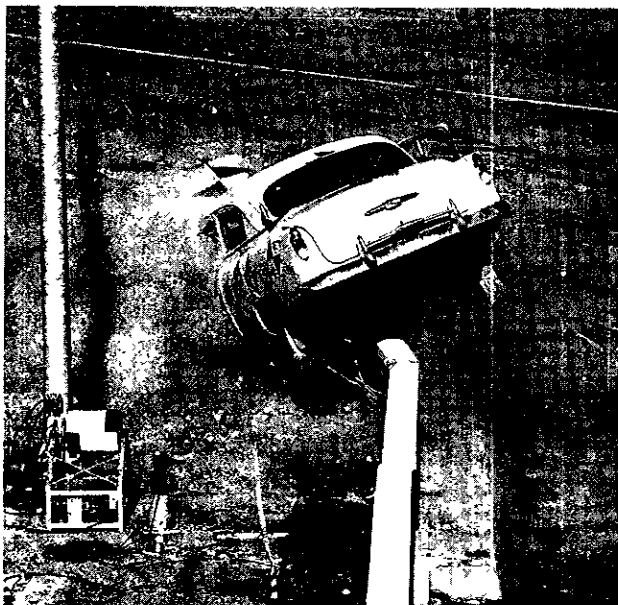
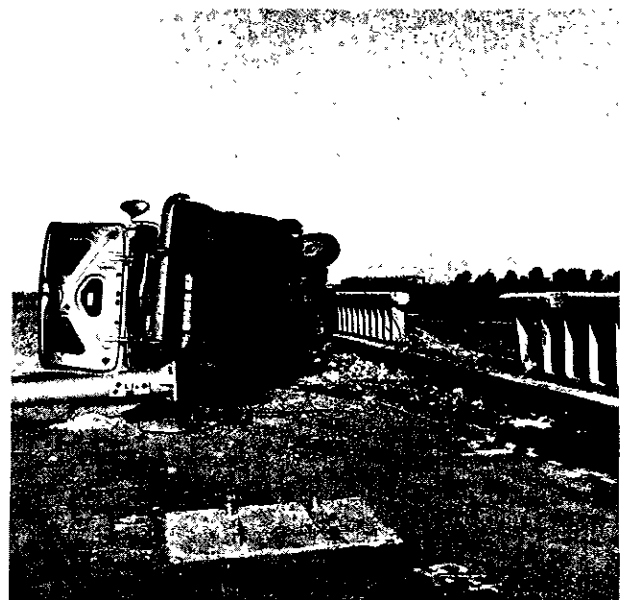
B. Baluster type rail tested during the 1959 test series. Impact speed 57 mph at 28 degrees approach angle.

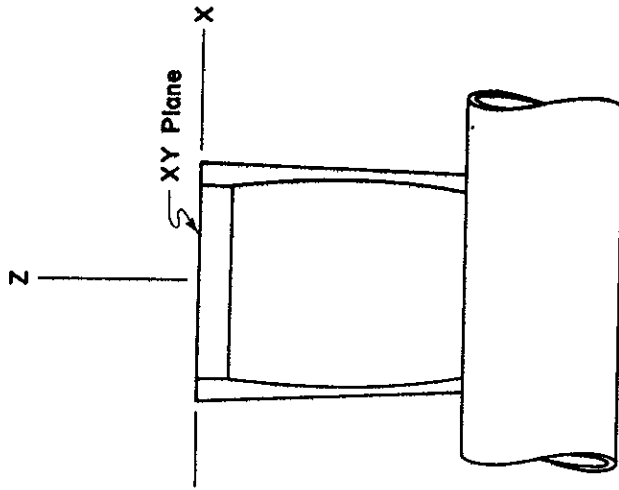
C. Place post in position as shown. Base plate in horizontal plane XY.

1. Bolt barrier railing post in test jig, apply test load to railing post as shown in Figure D and measure maximum load that the post will support without failure.
2. Take test sample from the railing post for determining the elongation, as shown in Figure E. Prepare standard test specimen and determine percent elongation as described in ASTM Designation: E8.

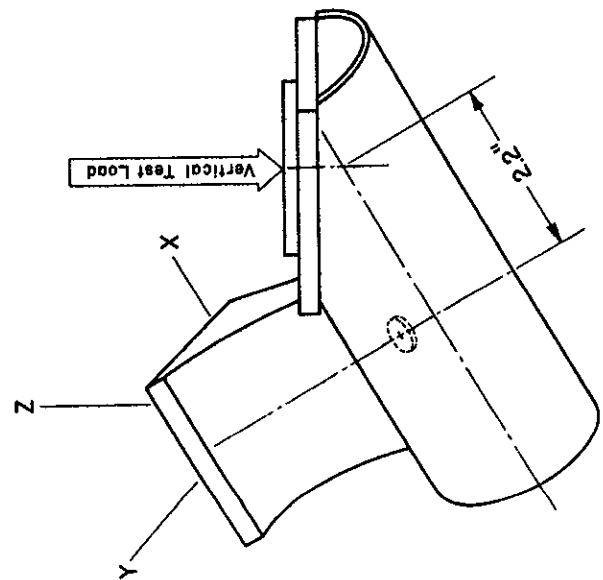
D. Apply vertical test load

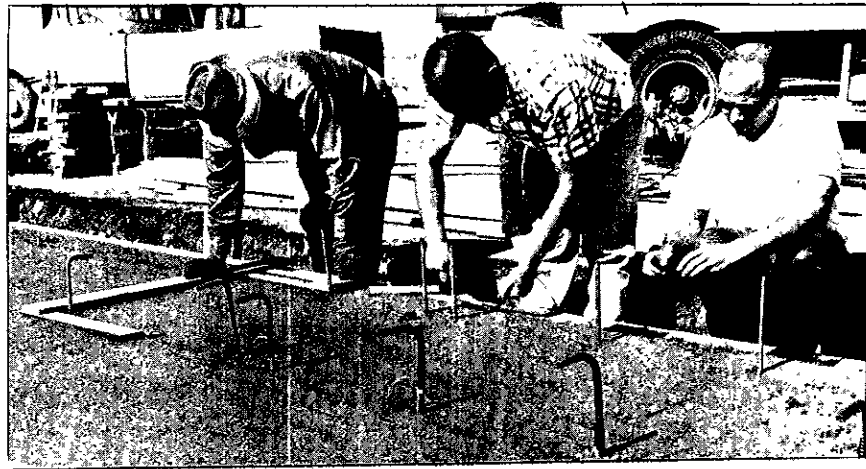
A. Installing strain gage instrumented re-bar dowels for barrier Type 2.

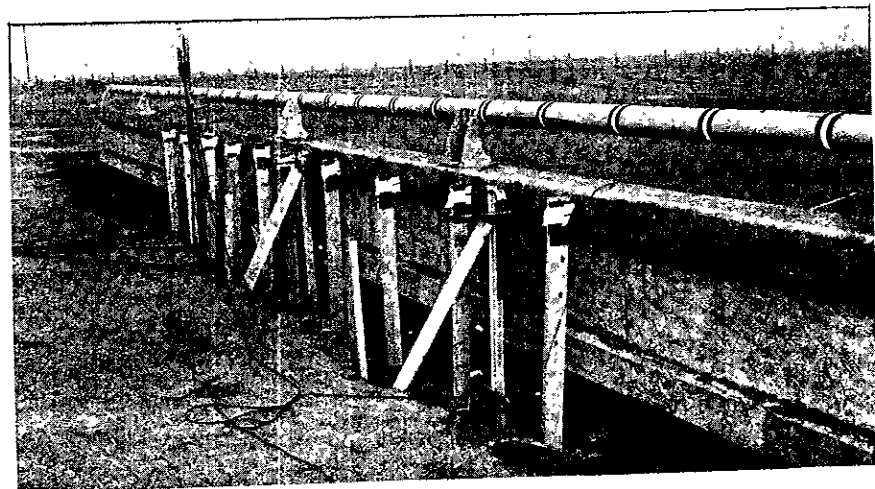
C. Deflection gage installation on Type 1 Modified Barrier Rail.

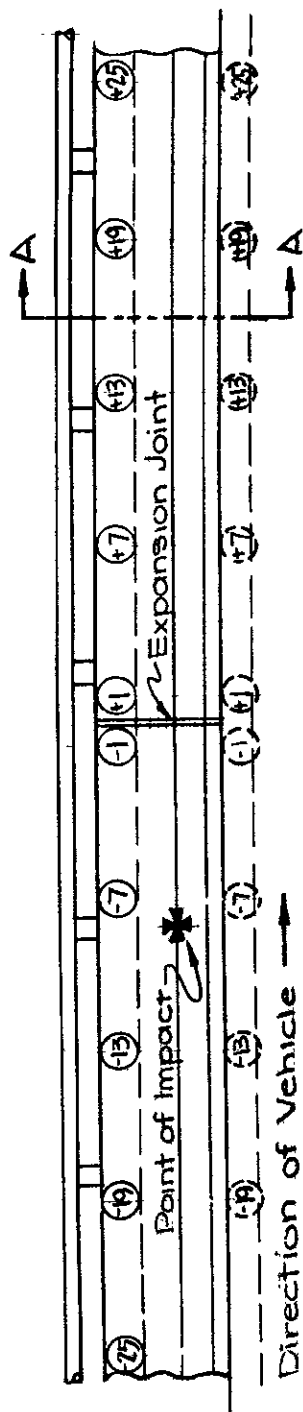
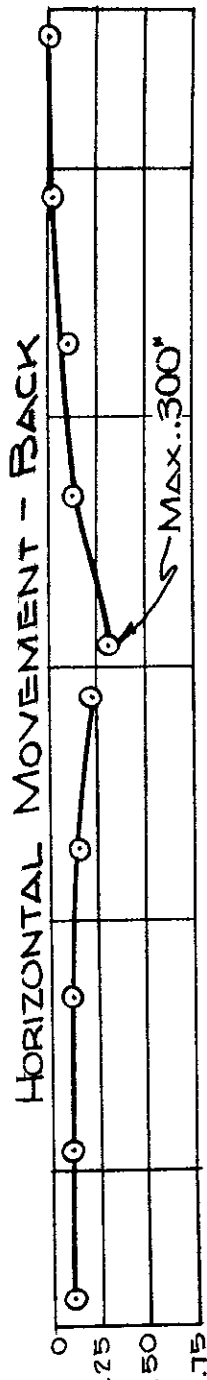
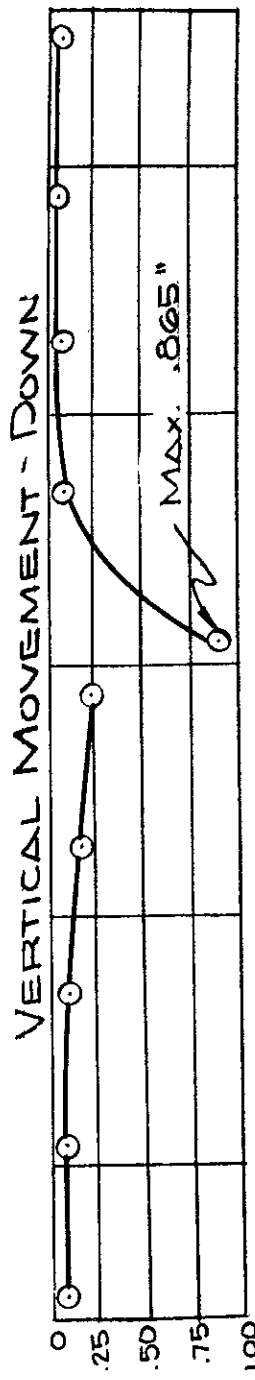
DECK GAGES
PARAPET GAGES
DEFLECTION IN INCHES

(B) DYNAMIC DEFLECTION OF PARAPET & DECK - RUN B-5

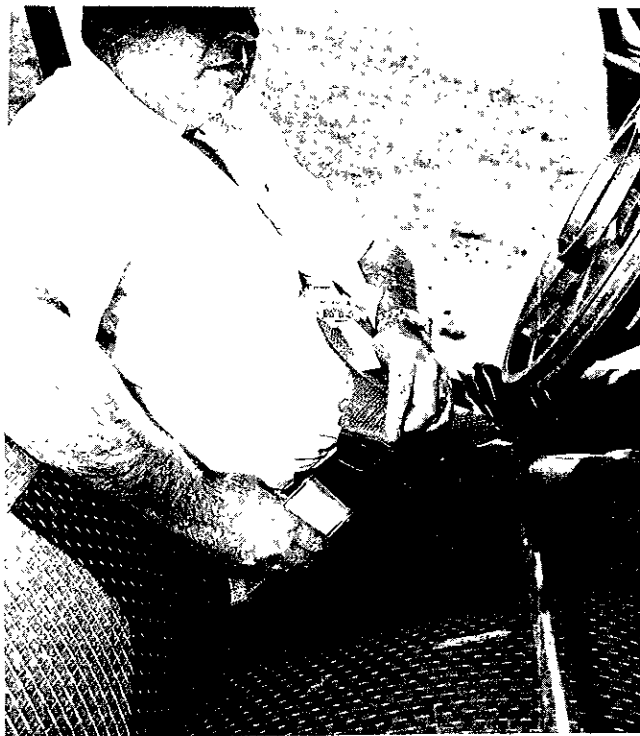
A. Type 1 Harness Buckle

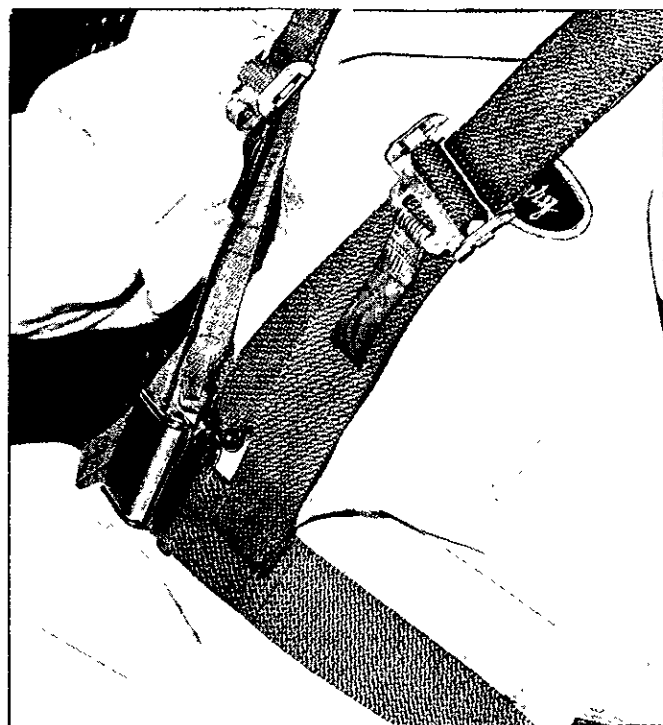
B. Harness Buckle
for Types 2 and 3.

1. The Type 3 shoulder harness was the only restraint tested that met this condition.
2. The shoulder straps on this lap belt/harness combination were fairly difficult to fasten into the buckle (see Exhibit 19-B). After impact the buckle was easily released with the pressure of two fingers.

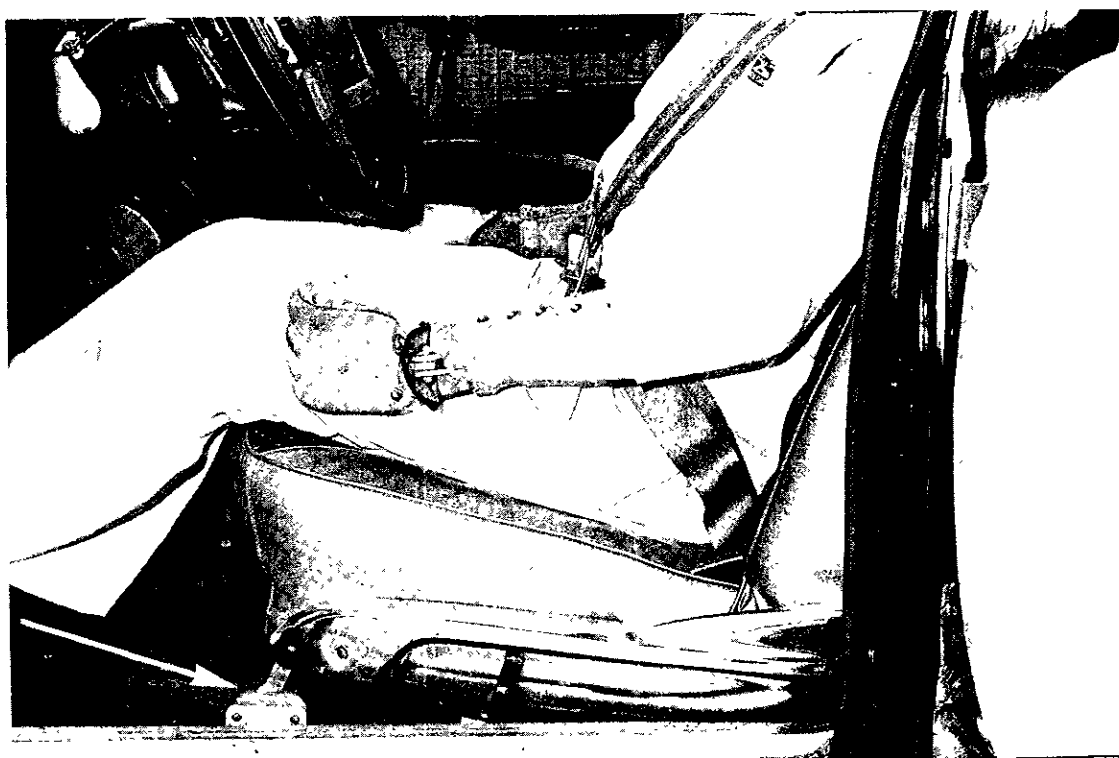
C. Type 4 Inertia Reel Harness showing Buckle and
Reel Release Lever at Left of Seat.

2. This harness is very easy to slip on. The lap belt is fastened first in the conventional manner and the shoulder strap lugs are then snapped into the buckle assembly (see Exhibit 19-C). After the impact, the buckle assembly could not be released by hand. The use of a pair of channel lock pliers was required to rotate the buckle cam to release position. It should be noted that the seat adjustment guides failed during this test and placed additional loading on the dummy and harness.
